PTPD REPORT NO. 76-36
AFPEA PROJECT NO. 76-P7-55

AIRTIGHTNESS TEST OF CASKET FOR HUMAN REMAINS

AFALD/PTP
AIR FORCE PACKAGING EVALUATION AGENCY
Wright-Patterson AFB OH 45433

October 1976

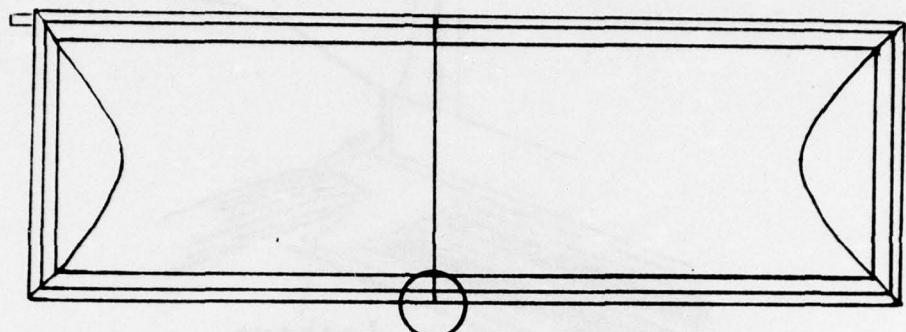
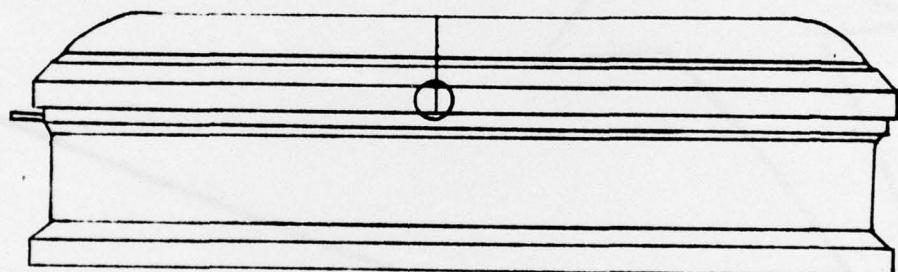
FIGURE 1

RESULTS AND DISCUSSION: The test results indicated the presence of one leak located as shown in Figure 1. Initial observations attributed the probable cause of leakage to misalignment of the two lids. Lid misalignment was obvious as both lids failed to line up "flush" at their interface. Further examination revealed that leakage occurred through the gap which would normally be filled by the gasket between the lids. Lid misalignment aggravated the seal by causing a larger cavity at the point of leakage and prevented the gasket from completely filling the cavity (see Figure 2).

Leakage Point

It was concluded that the casket submitted for test is adequately manufactured to achieve the structural integrity necessary for airtightness. It is, however, recommended that the lid gasket design be lengthened so that any slight misalignment of the lids will not affect the airtightness feature of the casket.
